Manhole Inspection Summary

Manhole # S21K1_013MH

Insp Date: **4/24/08 12:20 PM**

Location Address: **3103 savoy st**

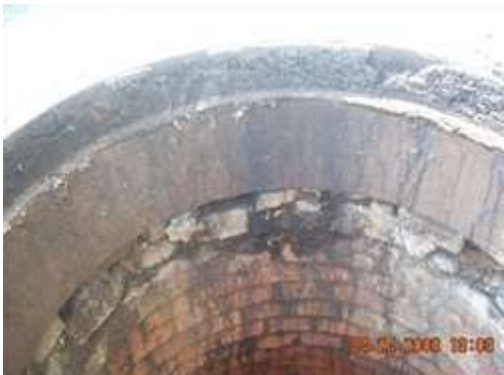
Defect 1

Infiltration: ☐ None ☒ **Joint** ☐ Cracks ☐ Mortar ☐ Roots ☐ Wall

infiltration @ chimney/frame joint; inflow evidence from sheeting

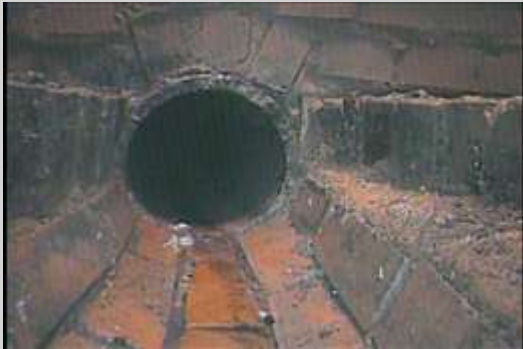
12 O'Clock Outflow

8 in. Circular Gravity Sewer
Pipe Out @ 12 O'Clock

Pipe Height: **8.4** (in.) Rod and Bar (Angled)
Pipe Material: **Clay** ☐ Pipe Lined
Invert Depth: **8.95** (ft.) Flow Characteristics: **Slow**
Deposits: ☒ None ☐ Mud ☐ Sludge ☐ Debris ☐ Grease
Silt Depth: **0** (in.) Deposits Extent:
Infiltration: **None** Pipe Seal Cond: **Sound**

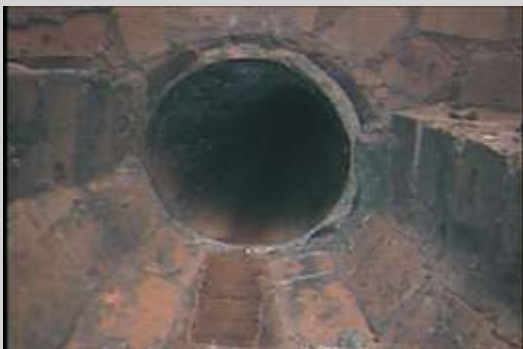
7 O'Clock Inflow

8 in. Circular Gravity Sewer
Pipe In @ 7 O'Clock

Pipe Height: **8.4** (in.) Rod and Bar (Angled)
Pipe Material: **Clay** ☐ Pipe Lined
Invert Depth: **8.64** (ft.) Flow Characteristics: **Slow**
Deposits: ☒ None ☐ Mud ☐ Sludge ☐ Debris ☐ Grease
Silt Depth: **0** (in.) Deposits Extent:
Infiltration: **None** Pipe Seal Cond: **Sound**
